'M/V JACKPOT'

Fishing Vessel, Seward Military Resort

Confidential Survey of Condition and Value, M/V JACKPOT

File # 12223

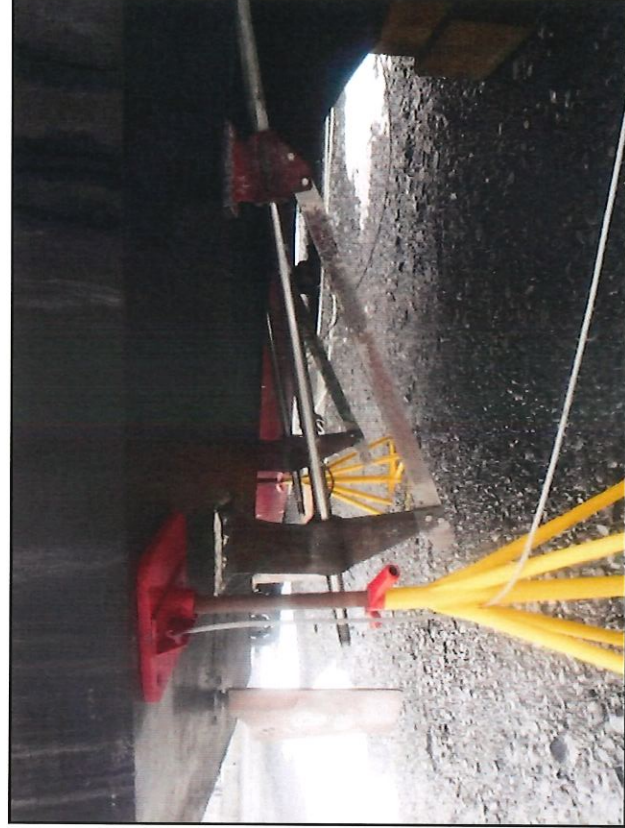
RUNNING GEAR: The shafts are through Cutless bearings mounted in forward and aft I-struts, with a bolted skeg below, struts, light bearing wear with runout <1/16", in good order.

Running gear

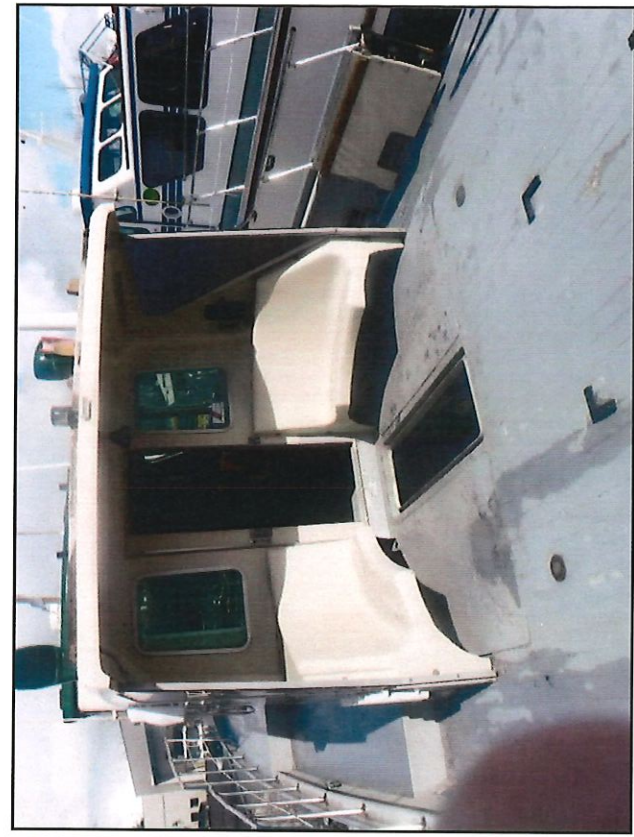
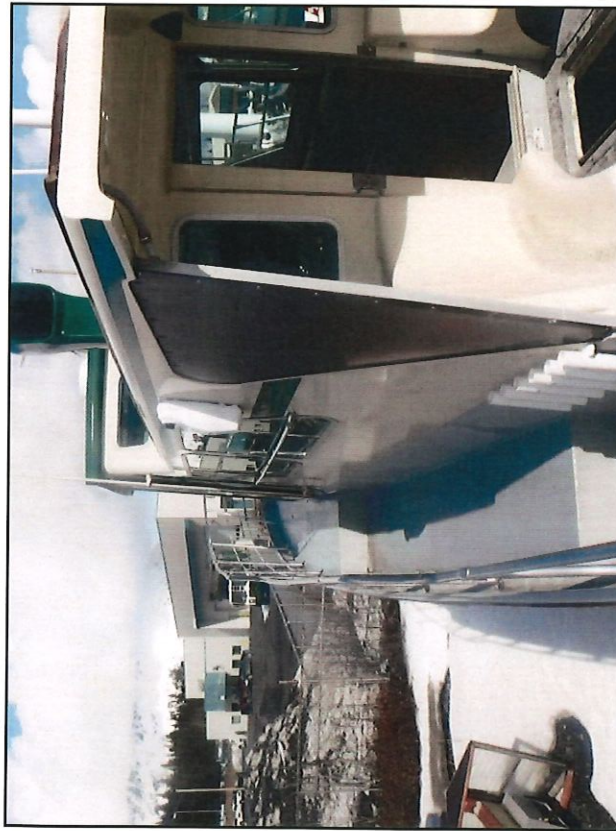
Port side deck

- 5) The lazarette hatch should be serviced and adjusted to make watertight.
- 6) The port side deck inboard grab rail has the aft mount loose at the deckhouse; repair and seal from leaks into the cabin core material.

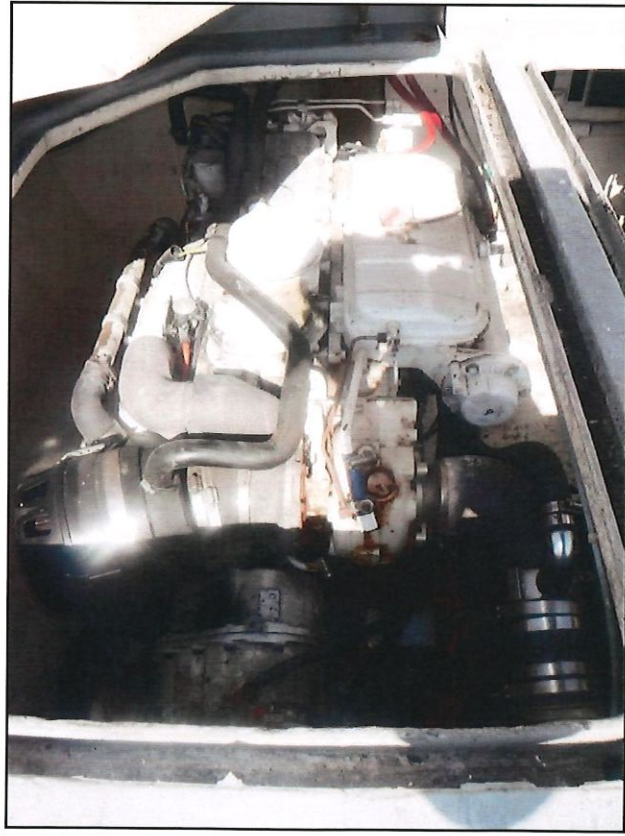
Port is a Caterpillar model 3126 six-cylinder diesel, serial #3GS02109, and starboard is a similar Caterpillar Model C-7, serial # CSX00532. Both are rated 315 horsepower, are turbocharged, electric start, fresh water and heat exchanger cooled and with seawater-cooled exhausts, and drive Twin-Disc model MG-507 hydraulic reverse and reduction gears at 2.05:1 ratio, to one piece 2" stainless alloy propeller shafts through conventional type packing glands at the stern tubes. There are 9,727 total service hours indicated port and 9,730. Ducting to the atmosphere provides adequate ventilation and air supply. The machinery is a replacement from original and appears in good repair.

Port engine

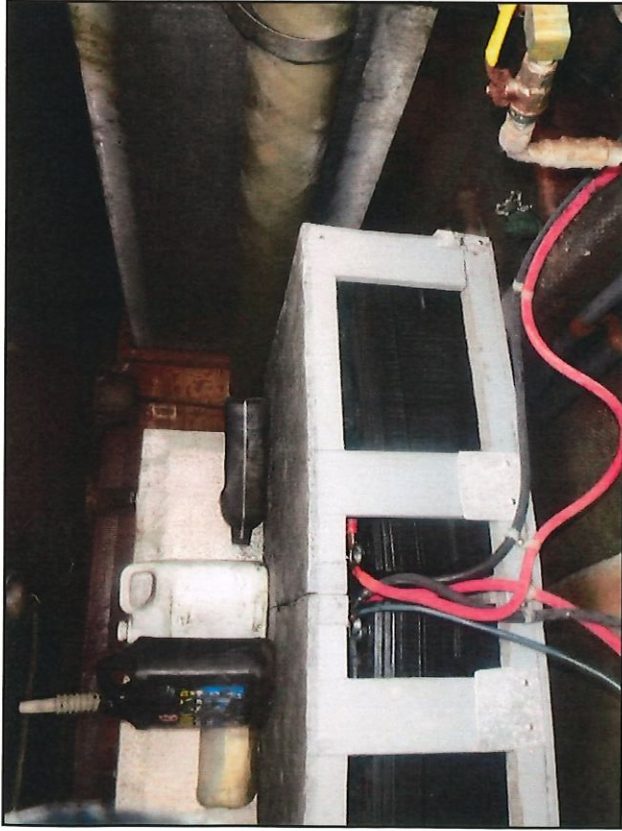
Batteries, tanks

- 2) Wingnuts securing large battery cables to the terminals should be replaced with hex nuts. (ABYC E-10.8.3)
- 3) The bulwark caprail at the boarding gate has cracked FRP; recommend grind out to sound material and rebuild to match remainder.
